Robison On Rovers

Carbon Fouling – A New Kind of Valve Job

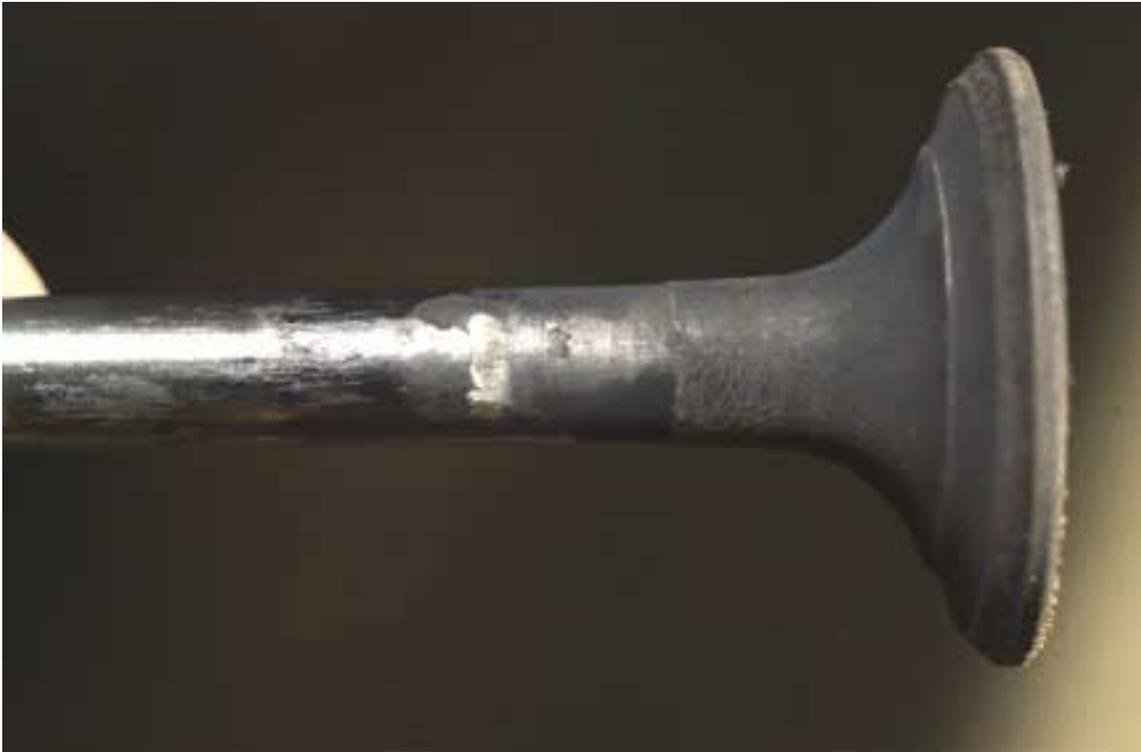
If you remove and check several exhaust valves you will probably see a big difference between a few. Good valves seat shut with a positive click. Sticky valves bind before they close. The feel is quite different.

Here's a picture of a sticky valve

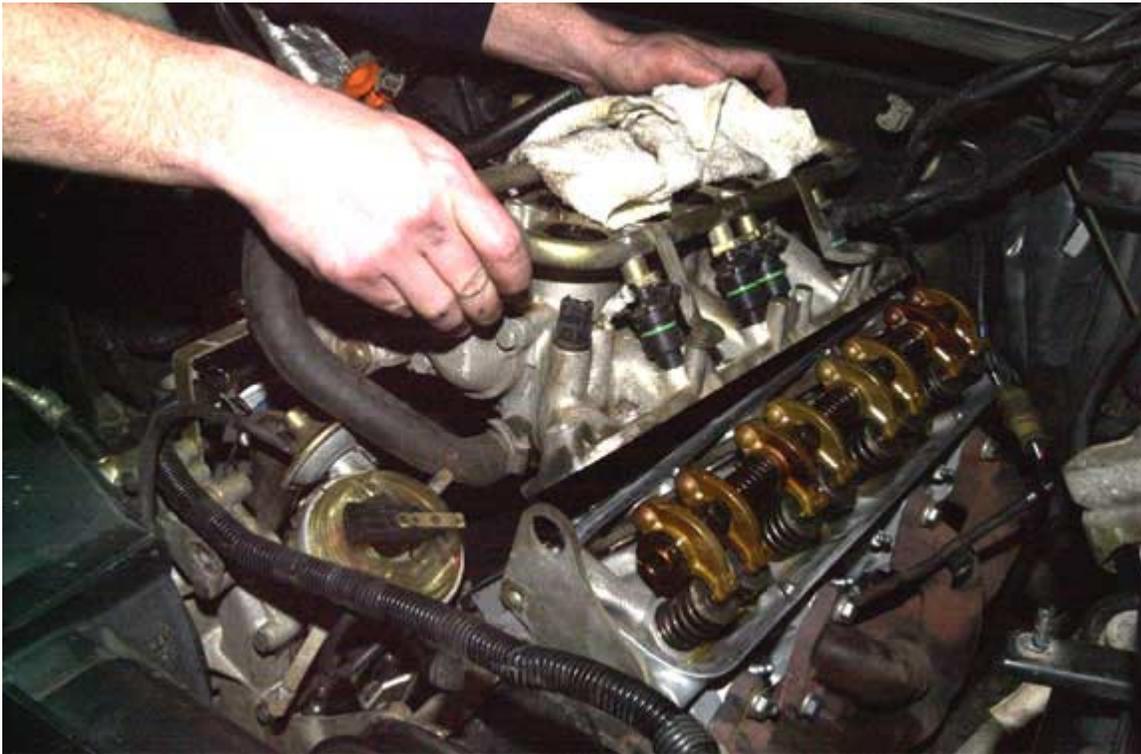
Next we remove the intake duct and hoses, the power steering pump (moved aside), the alternator (moved aside), and everything else on top of the motor. After removing the plenum cover and disconnecting the fuel lines, we remove the intake manifold complete with injectors and fuel rail. Note that we've left quite a few pieces installed. This speeds the work considerably. Some of you might also notice that a distributor has appeared on the front of the engine. That's because the pictures in this series were taken from two valve jobs – one a 96 Disco with carbon fouling, and the other (below) a 93 Range Rover with a burnt valve. I've used whichever images best illustrate the relevant points in this story.

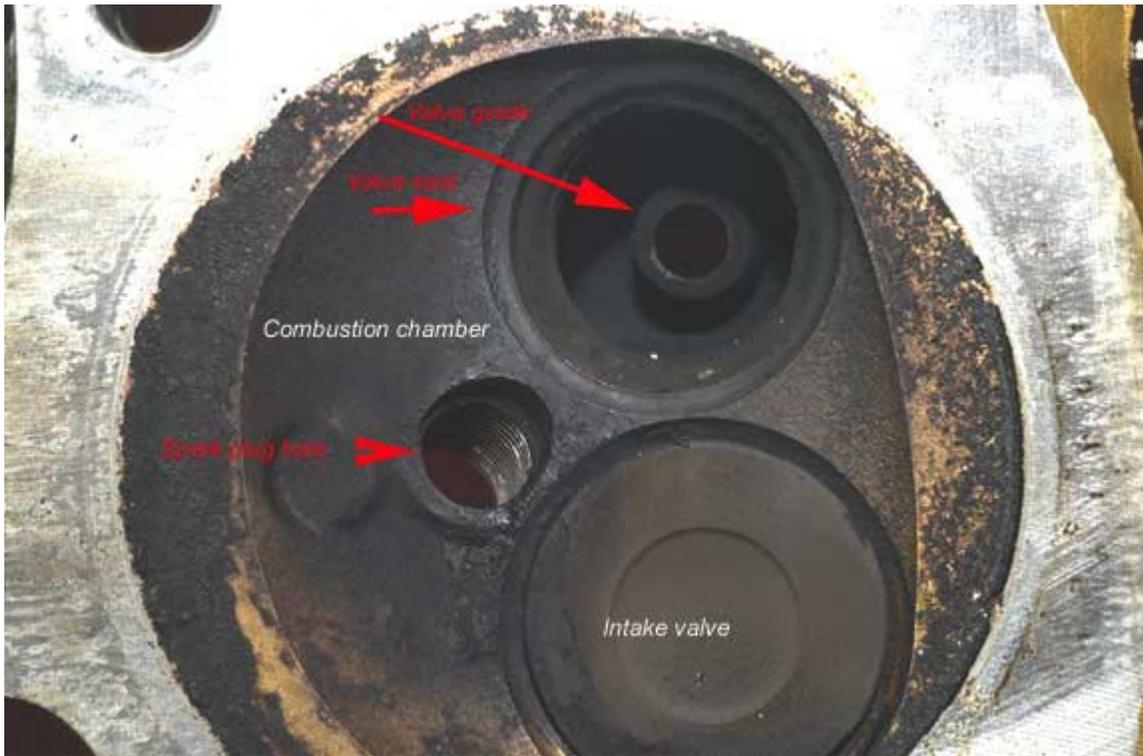
Here we've removed the valve, and the carbon buildup on the seat is quite evident. With carbon buildup like this on the seat, it's a safe bet this engine was down on power all the time. Once we've fixed it it's owner will surely see an increase in performance. The hole in the center of the port is the valve guide. The guide, seat, and head look like areas on one piece of metal but they are actually three distinct parts.
