Robison On Rovers #3, April 20, 2000

Robison On Rovers

Carbon Fouling – A New Kind of Valve Job

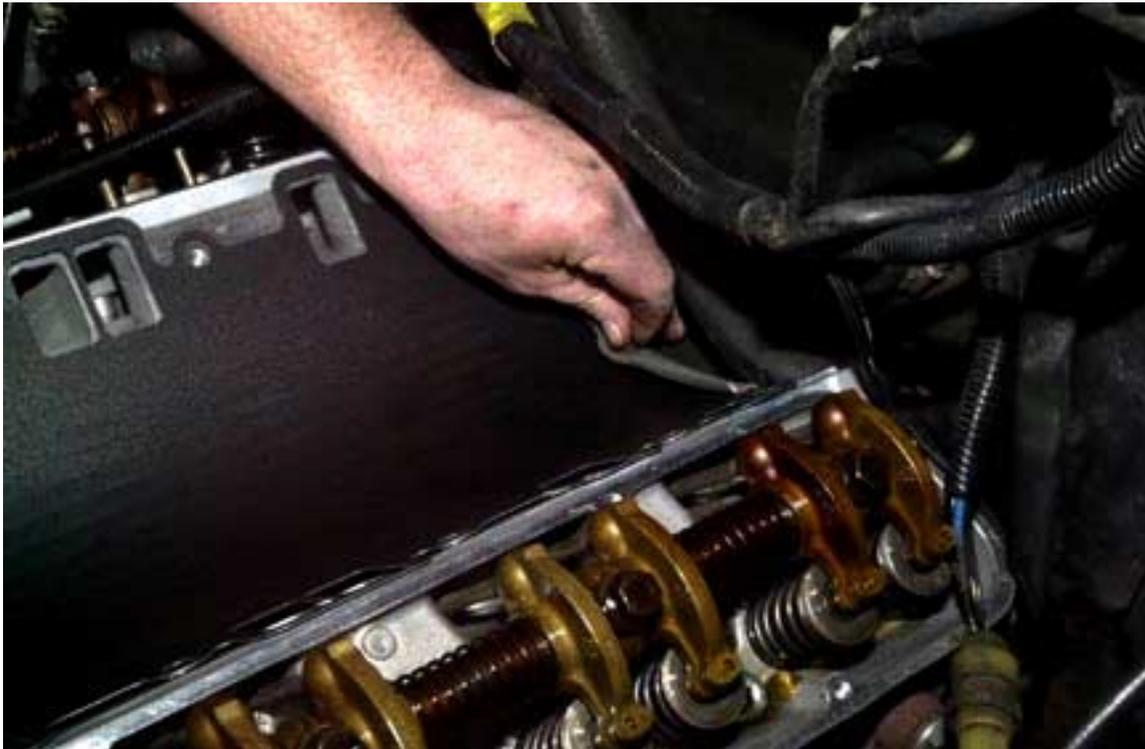
Don't forget to secure this gasket to the block as shown before setting the intake in place. Metal strips secure each end of the valley gasket to the block. Leaks from this area are often mistaken for rear main seal leaks as oil tends to run out the rear of the motor at the transmission joint. The new gaskets are designed to seal without any additional sealants but we use *Hylomar* just to be sure. In the photo below the technician is securing the rear of the valley gasket to the block.

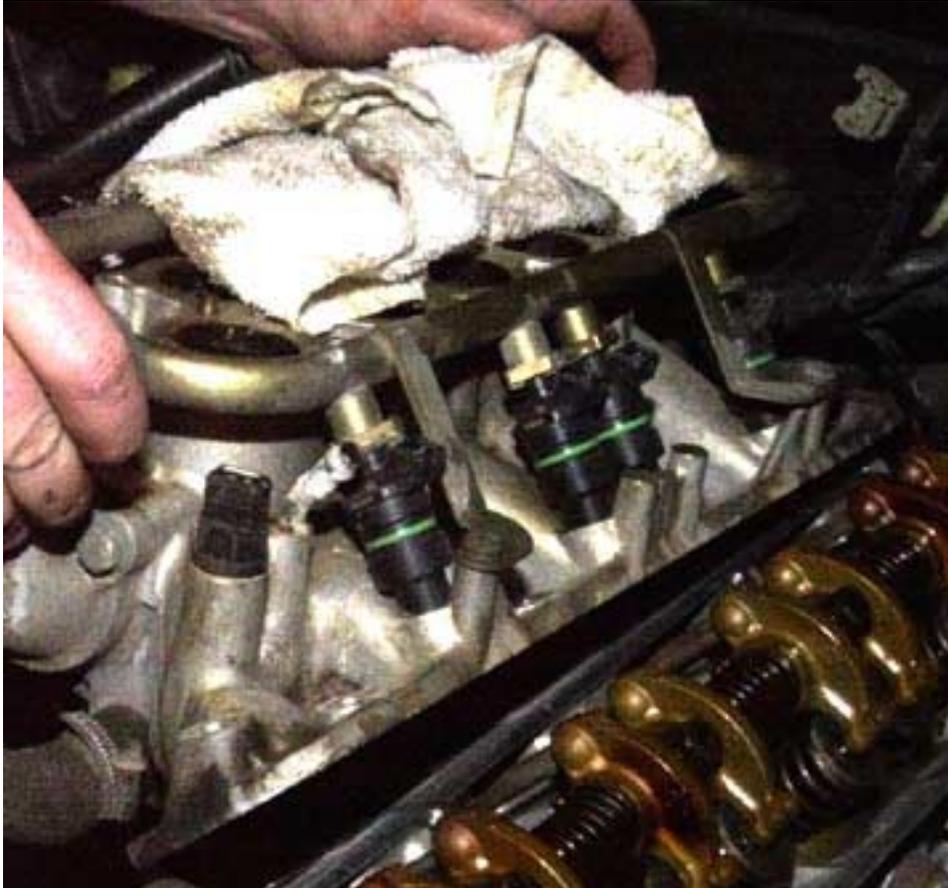
Next the intake assembly is fitted. Note that we saved time by leaving the fuel rail and sensors installed.

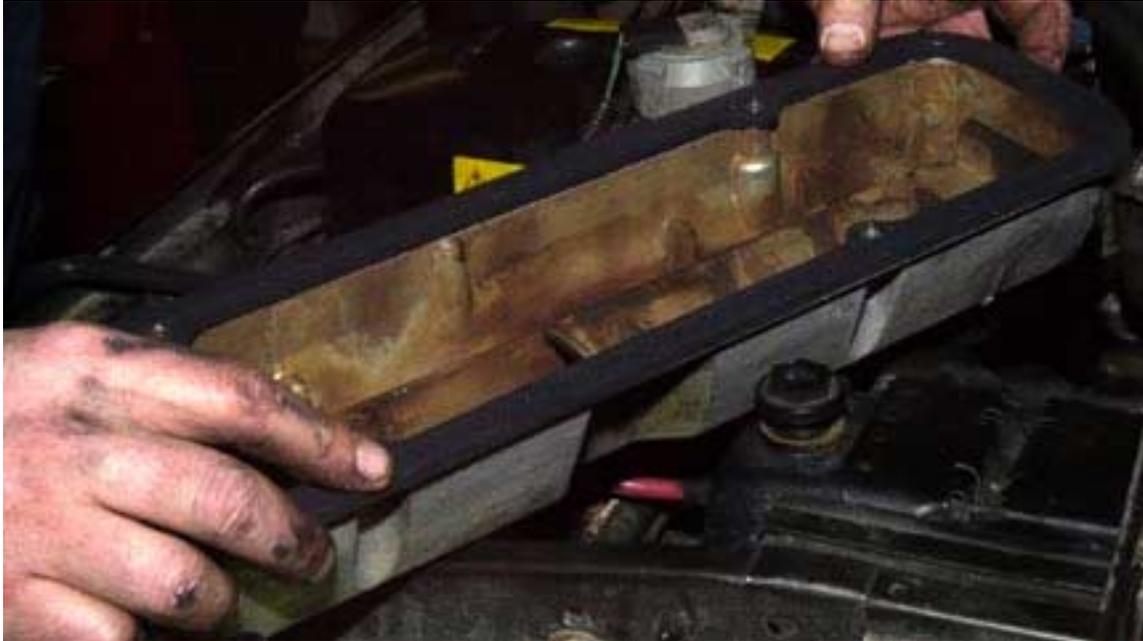
Make sure you install the new rubber valve cover gaskets. If your truck had cork gaskets you'll also need new screws. They are not part of the head gasket kit.
